AFRL-ML-WP-TR-2000-4153

**HYDROGEN EMBRITTLEMENT OF
METAL FASTENERS DUE TO
PHOSPHORIC ACID CONTAINMENT
SYSTEM (PACS) EXPOSURE
VOLUME 5 - DELIVERY ORDER 4, TASK 2**

FINAL REPORT FOR PERIOD OF 13 SEPTEMBER 1996 – 30 SEPTEMBER 1997

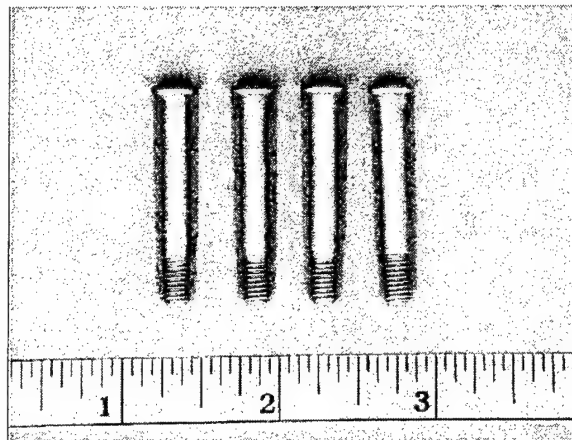
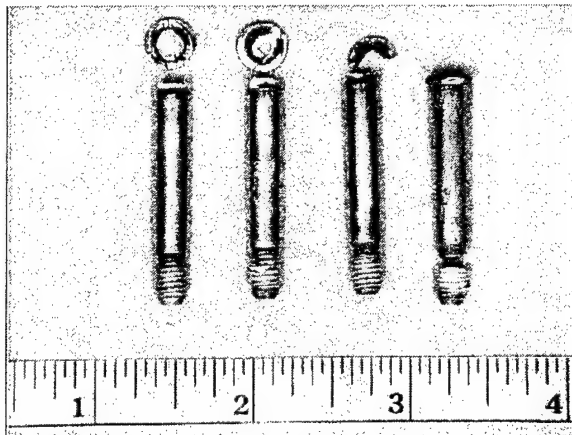
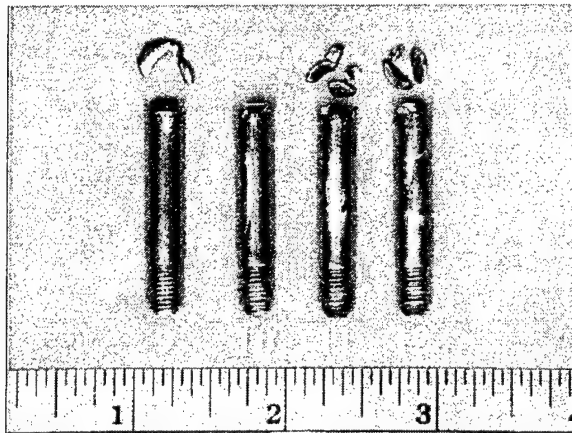
Fastener Conditioning Prior to Sustained Loading		
As-Received (No PACS)	As-Received (PACS)	Stripped (PACS)
HL14-1----Pass	HL14-5----Fail ¹	HL14-9-----Fail ³
HL14-2----Pass	HL14-6----Fail ¹	HL14-10-----Fail ³
HL14-3----Pass	HL14-7----Fail ¹	HL14-11-----Fail ³
HL14-4----Pass	HL14-8----Fail ²	HL14-12-----Fail ³

¹ Failed at head during sustained loading. Failure occurred instantly upon load application. Contained no cracking in threads.

² Failed in threads during PACS exposure. The length of time until failure was unable to be determined. Contained no cracking at the head.

³ Partial failure at head during PACS. The length of time until partial failure was unable to be determined. Complete failure at head occurred instantly upon application of the sustained load. Contained no cracking in the threads.

Figure 6. Overall Photos of the Tested HL14 Fasteners. All of the fasteners exposed to PACS failed at either the head (7 each) or in the threads (1 each).

The HL14 fasteners partially failed at the heads during the PACS exposure. The fasteners then completely failed at the head within the first few seconds of the sustained loading. These fasteners showed no signs of cracking in the threads. Once again, the fracture surfaces of the HL14 fasteners displayed areas of black discoloration (believed to be acid penetration during the PACS exposure).

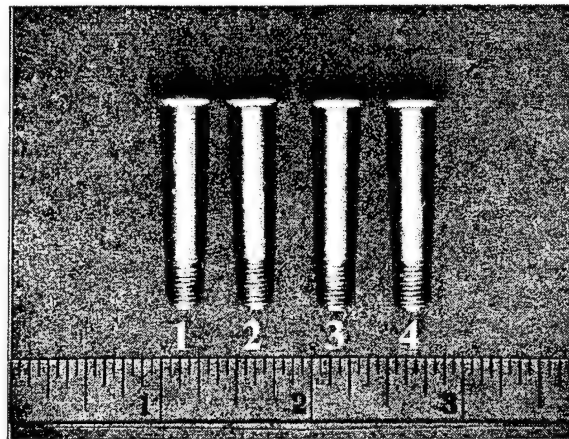
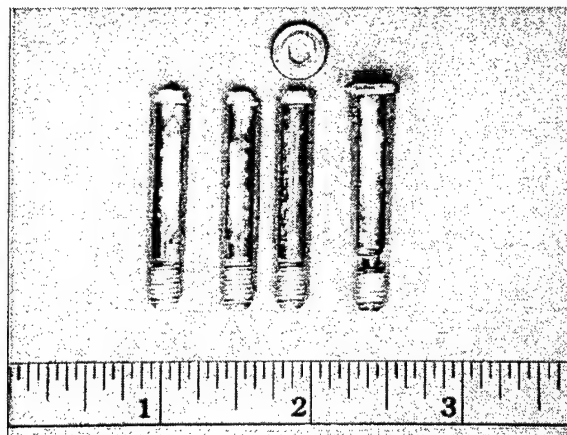
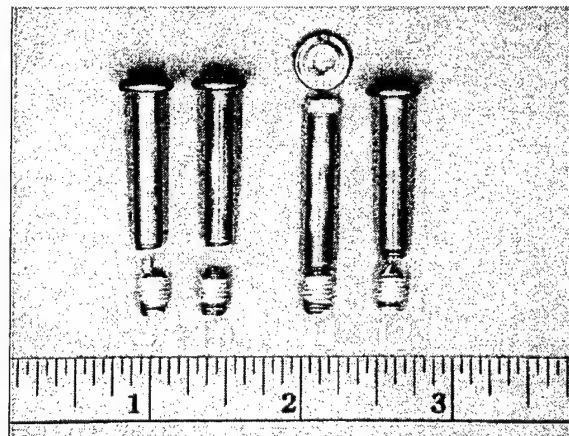
Fastener Conditioning Prior to Sustained Loading		
As-Received (No PACS)	As-Received (PACS)	Stripped (PACS)
HL32-1----Pass	HL32-5----Fail ¹	HL32-9----Fail ²
HL32-2----Pass	HL32-6----Fail ¹	HL32-10----Fail ²
HL32-3----Pass	HL32-7----Fail ¹	HL32-11----Fail ¹
HL32-4----Pass	HL32-8----Fail ²	HL32-12----Fail ²

¹ Failed at head during sustained loading. Failure occurred instantly upon sustained load application. Contained cracking in the threads.

² Failed in threads during sustained loading. Failure occurred instantly upon sustained load application. Contained cracking at the head.

Figure 8. Overall Photos of the Tested HL32 Fasteners. All fasteners exposed to PACS failed at either the head (4 each) or within the threads (4 each).

The HL32 fasteners all failed within the first few seconds of sustained loading. Three of these fasteners failed within the threads while one failed at the head. Once again, the fasteners that failed at the head also exhibited cracking in the threads and vice versa.

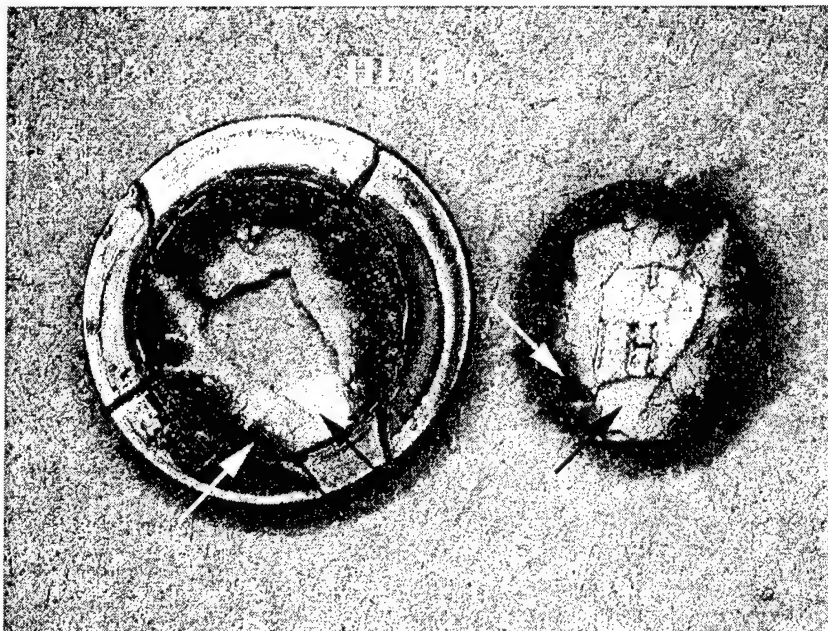
All but one of the HL14 fasteners failed at the head during the sustained loading. Figure 10 shows an increased magnification photo of the fracture surface of the HL14-6 fastener that failed at the head. It was observed that much of the fracture surface was black in color. It is believed that this black area was caused by the phosphoric acid during the PACS exposure. Since the HL14 as-received with no PACS exposure fasteners did not fail and did not contain cracks either in the threads or around the head, it would appear that the cracks developed during the PACS exposure. One HL14 fastener failed within the threads during the PACS exposure. Much like the failure at the heads, the fracture surface was blackened due to the phosphoric acid.

Figure 10. Increased Magnification of the Mating Fracture Surfaces of Fastener HL14-6's Head Failure. The white arrows identify a blackened fracture surface (believed to be caused by acid penetration into a crack). A clean metallic fracture surface (no acid penetration) is shown by the black arrows.

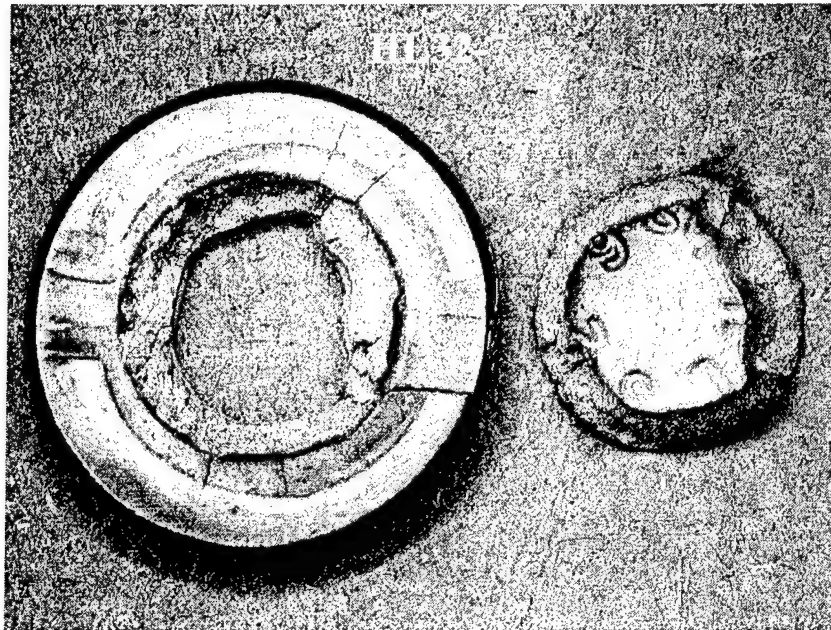
In the case of the HL32 fasteners, three failures occurred at the head and one in the threads. The fasteners that failed at the head, Figure 11, also displayed cracking in the threads, Figure 12. The reverse was also true (i.e., the fastener that failed in the threads also displayed cracking at the head), as shown in Figures 13 and 14. No blackened areas were noted on the fracture surfaces of the HL32 fasteners. Therefore, it was believed that no cracking existed prior to the sustained loading.

Figure 11. Increased Magnification of the Mating Fracture Surfaces of Fastener HL32-7's Head Failure.

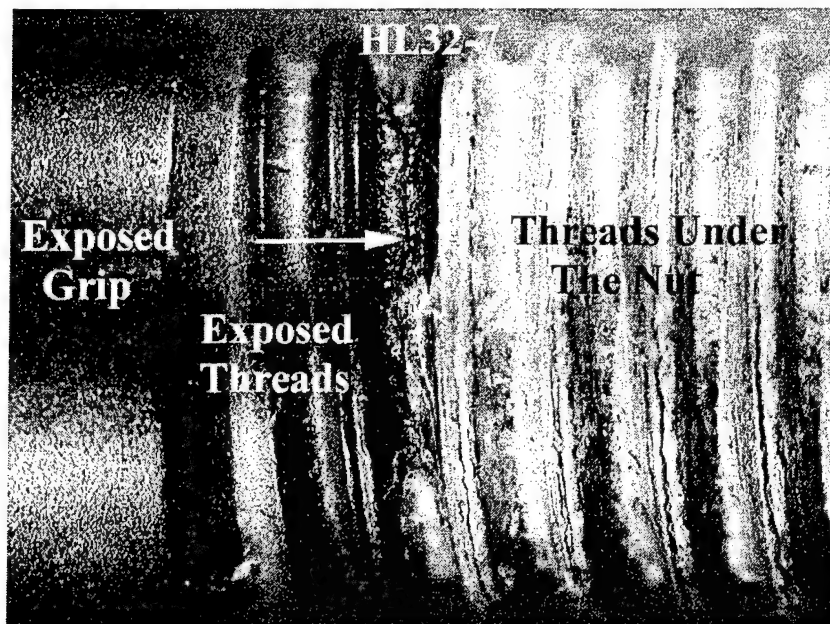
Figure 12. Increased Magnification of Cracking in the Threads of Fastener HL32-7. Arrow identifies the cracking located in the exposed/loaded threads.

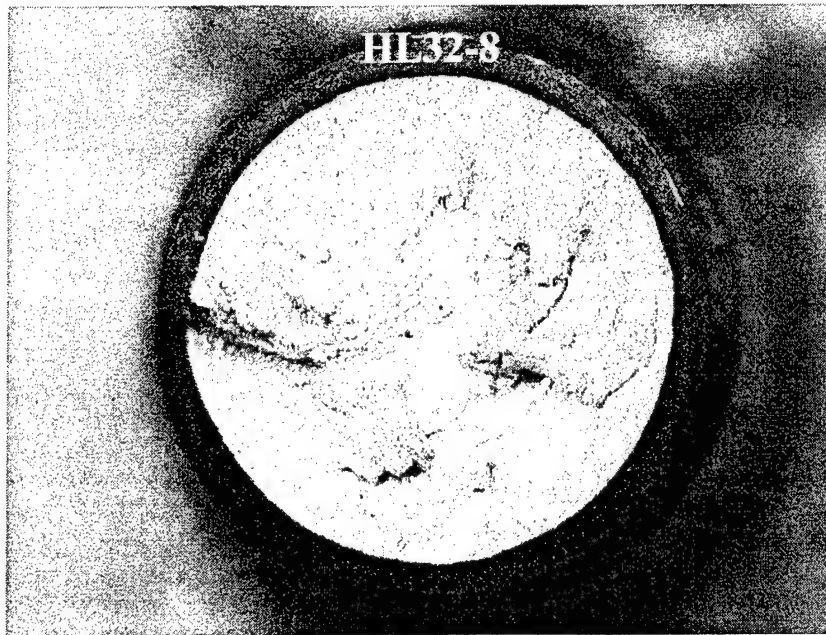
Figure 13. Increased Magnification of a Failure in the Threads of Fastener HL32-8.

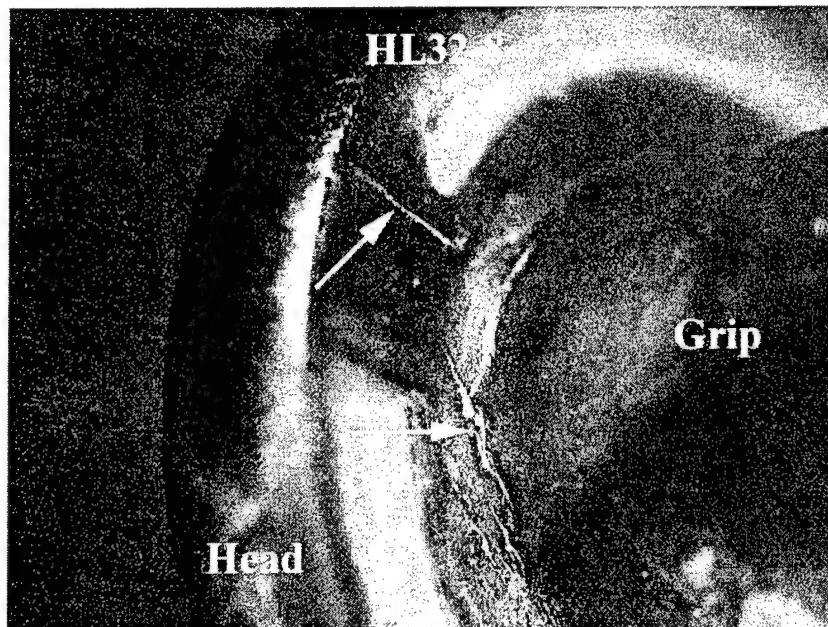
Figure 14. Increased Magnification of Cracking at the Head of Fastener HL32-8. The white arrows indicate cracking seen at the head and at the head/grip radius.
